Type 1 Facility Closeout Report

Facility No. Building 764 and Building 765
Facility Descriptor: Building 764 was the PIDAS building
Building 765 was the secondary alarm system building
Project: RISS
Date of Demolition: July 20, 2005
Additional Information:
(Must include information on environmental releases and conditions of site at turnover to Environmental Restoration)

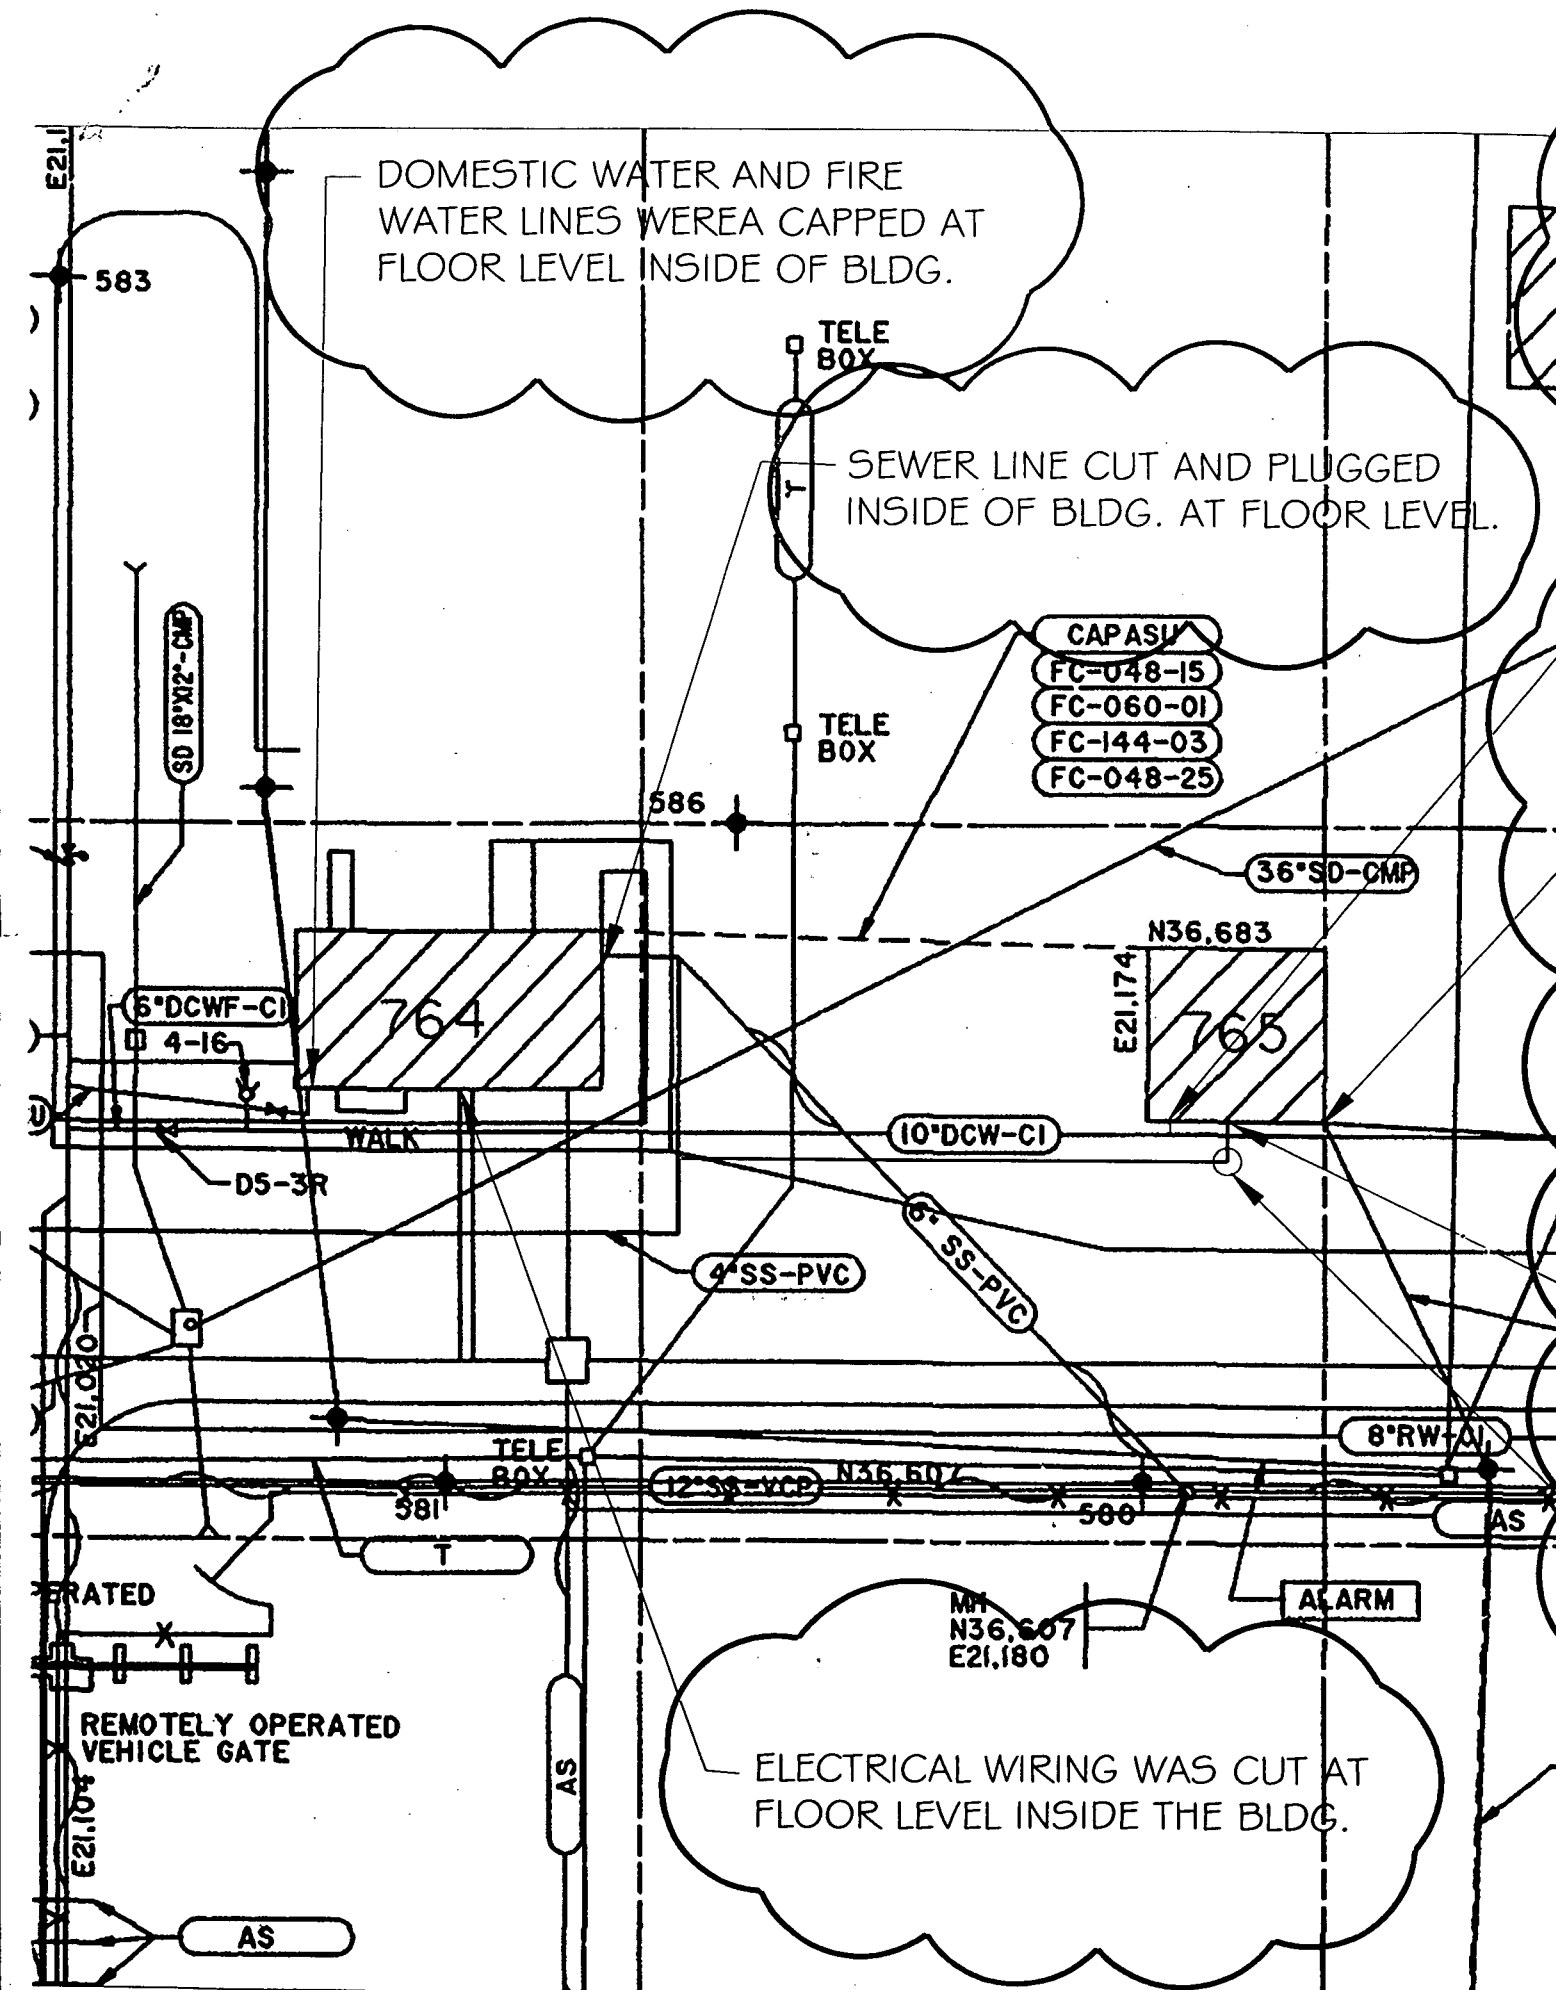
DOMESTIC WATER AND FIRE
WATER LINES WERE CAPPED AT
FLOOR LEVEL INSIDE OF BLDG.

SEWER LINE CUT AND PLUGGED
INSIDE OF BLDG. AT FLOOR LEVEL.

ELECTRICAL WIRING WAS CUT AT
FLOOR LEVEL INSIDE THE BLDG.

SEWER LIFT STATION REMOVED TO 5
FEET BELOW GRADE AND LINE
RUNNING INTO BLDG. WAS
REMOVED.

Utilities were all removed/disconnected as shown on the attached map.

NOTE: DURING BLDGS. 764 &
765 DEMOLITION ALL UTILITIES
WERE REMOVED TO 4 FEET
BELOW GRADE.
